11 DAMAGE TO LIFELINES

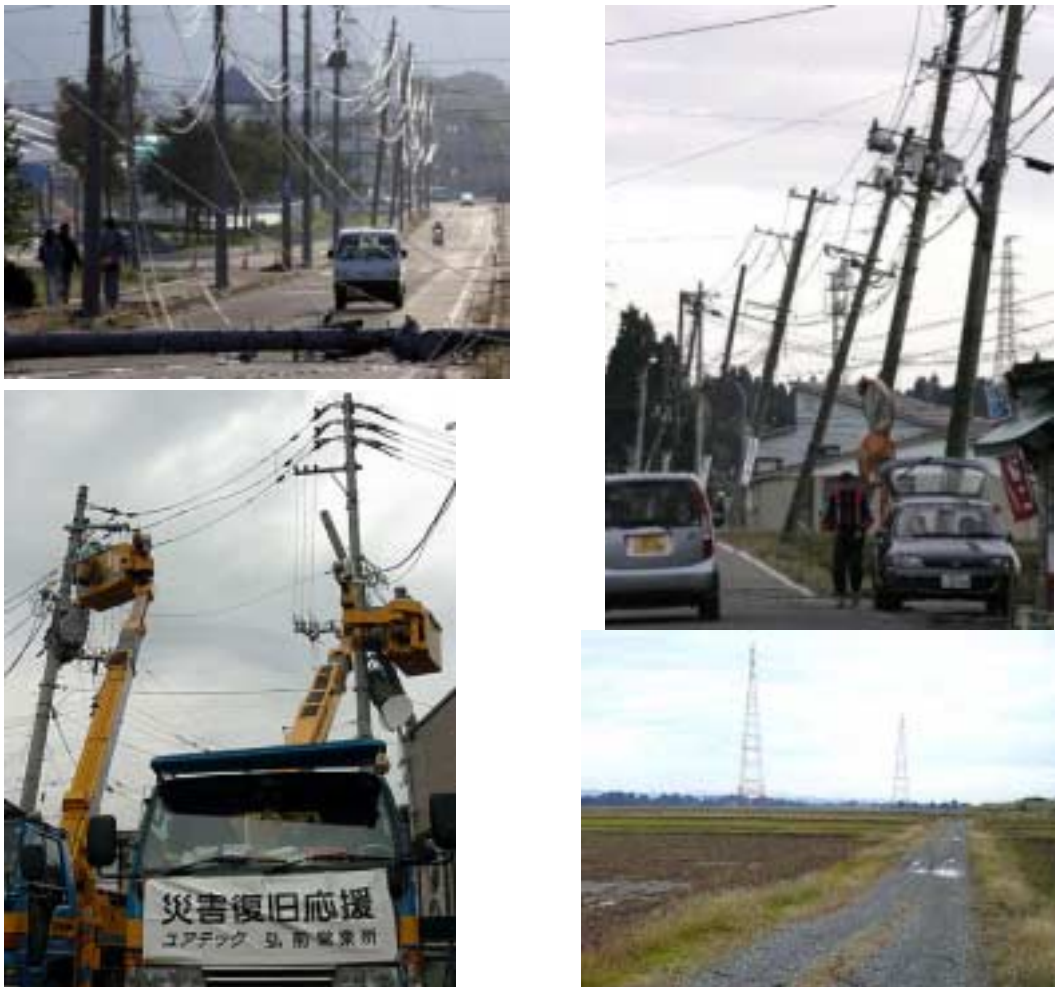
The electric supply to the earthquake stricken area was shutdown following the earthquake. Except heavily damaged areas, the electricity was restored after three days following the earthquake. The electricity distribution system in the region is done through poles and high-voltage transmission lines. Concrete poles were either inclined as a result of partial bearing failure of the surrounding ground or collapsed (Figure 11.1). The poles having transformers mounted on were particularly suffered more and also the poles were inclined in heavily liquefied areas. Nevertheless, the repair works on electricity distribution system could be accomplished in a short period of time.

Figure 11.1: Damage to electric transmission lines (Pictures from various web-sites)

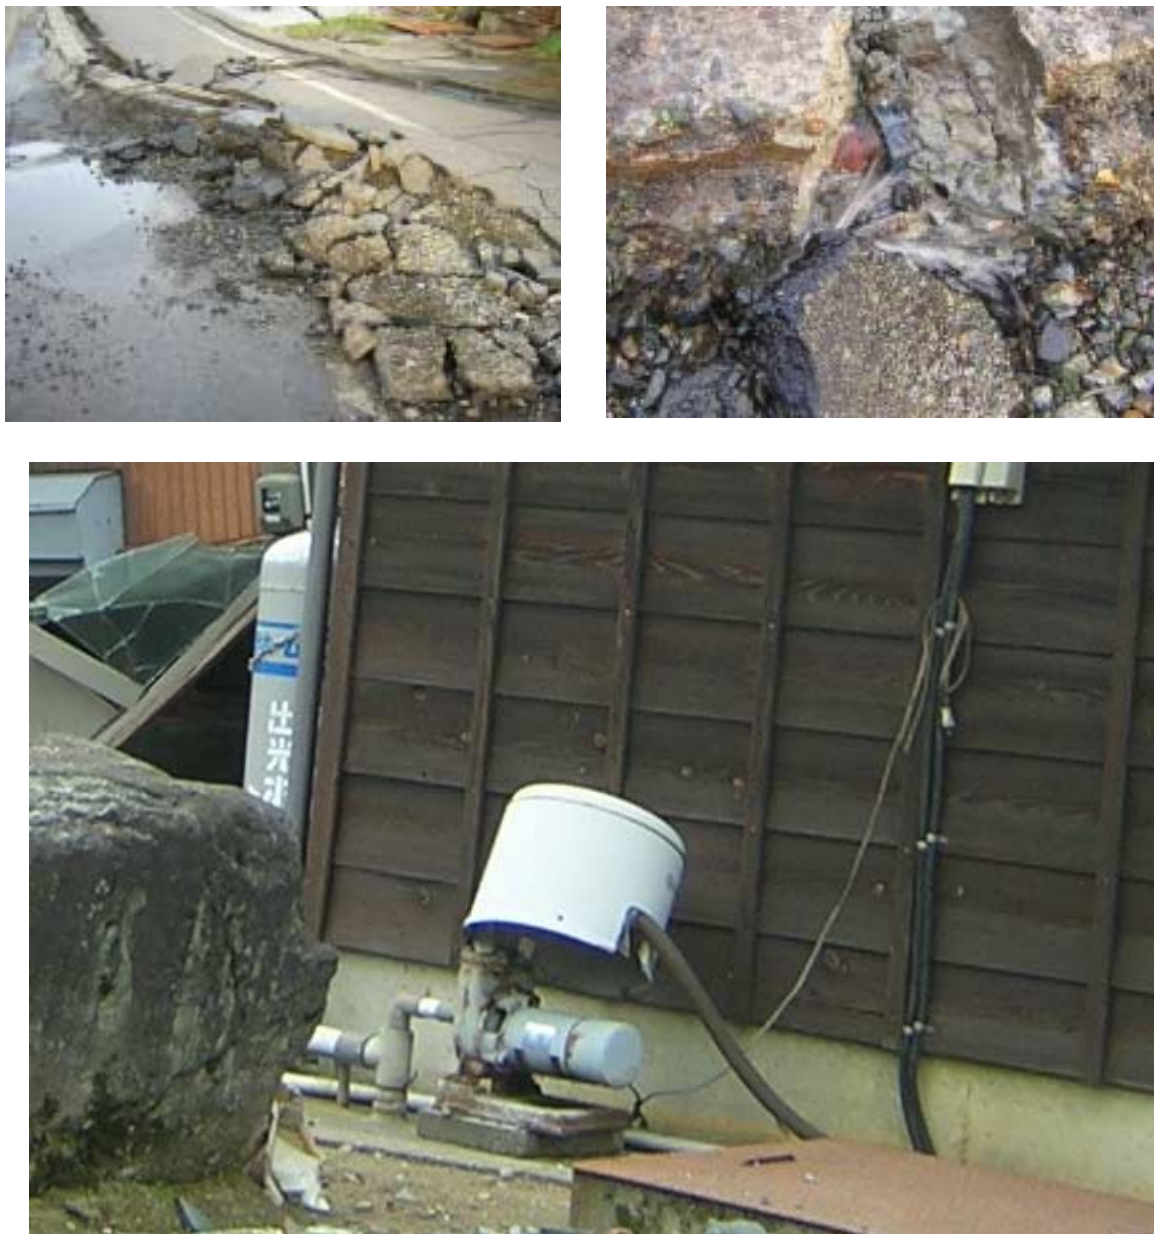
The water networks were particularly damaged in Ojiya city, Tokamachi and Kawaguchi towns. The damage to water network is generally associated with pipe breakage at joints (Figure 11.2).

Figure 11.2: Damage to water network

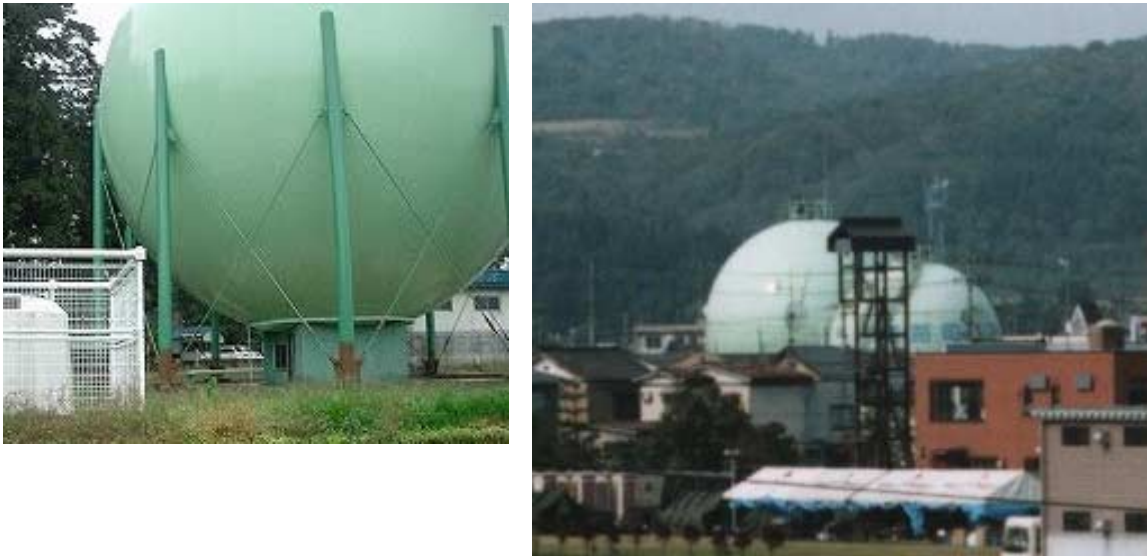
The natural gas systems consist of spherical storage tanks and distribution network. There was almost no damage to spherical gas storage tanks all over the epicentral region although slight damage could be seen at their foundations and connection pipes (Figure 11.3). Although the region is less populated and the networks are not so extensive, the gas supply could not be in operation in Ojiya and Kawaguchi. Since permanent ground deformations due to either soil liquefaction or associated with and faulting did take place, the regional gas company together with help from other gas companies of Japan have been now checking the gas pipe network block by block. The natural gas system is expected to be fully in operation after 1 month according to local gas company officials.

Figure 11.3: Non-damaged spherical gas tanks

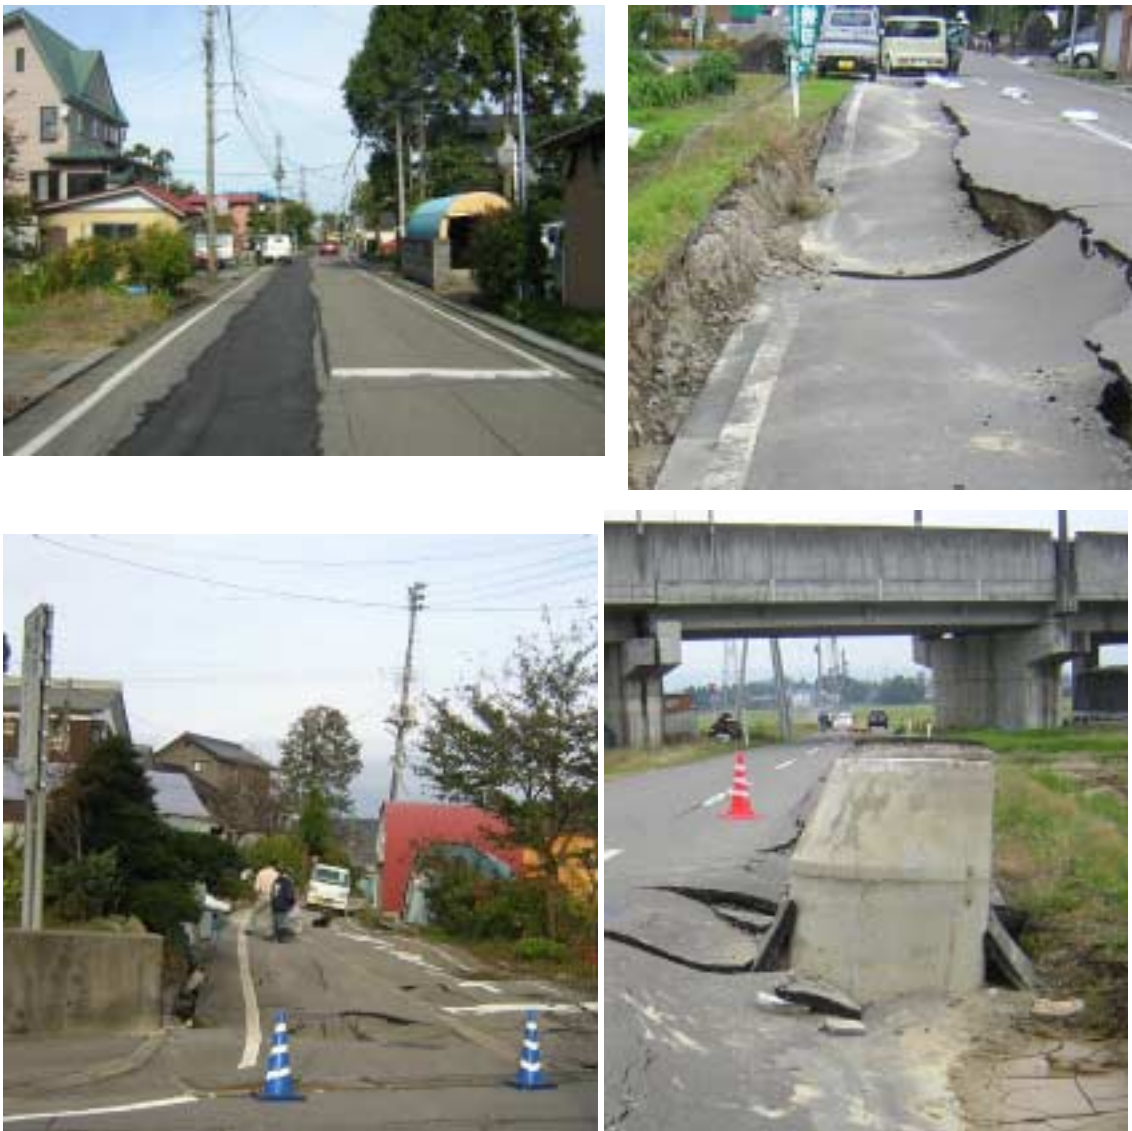
The sewage systems were heavily damaged by the liquefaction of back-fill soil (Figure 11.4). The uplift of manholes could be observed even in Teradomari town along Japan Sea. The uplift of manholes was as much as 1000mm. This implies both long-duration large ground shaking. The local authorities now have been checking the sewage system and replacing the sections underwent uplift or ruptured. Since the permanent ground deformations occurred due to lateral spreading of ground as a result of liquefaction, the joints of the sewage system suffer some leakage and need repairs

Figure 11.4: Damage to sewage systems
