## 8 GEOTECHNICAL DAMAGE

### 8.1 Soil Liquefaction and Lateral spreading

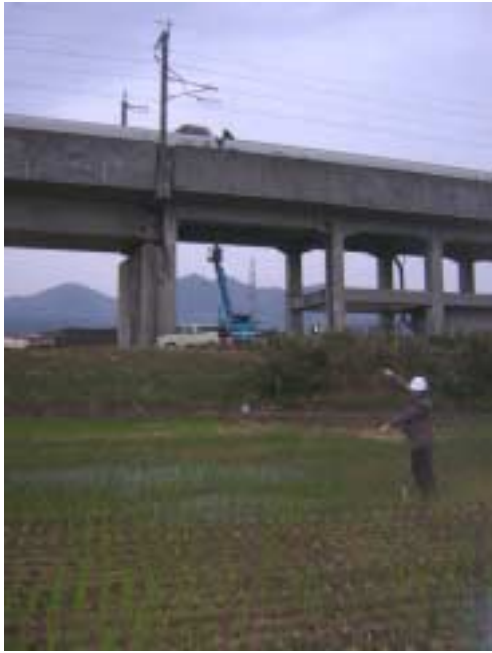
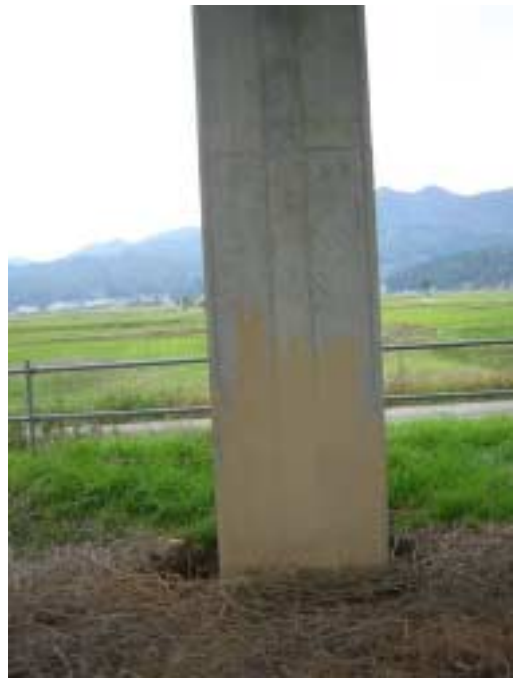
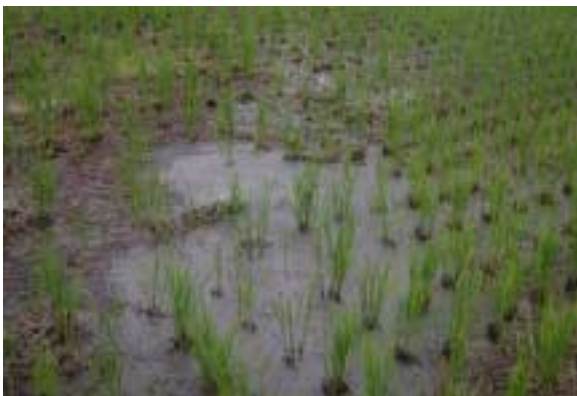
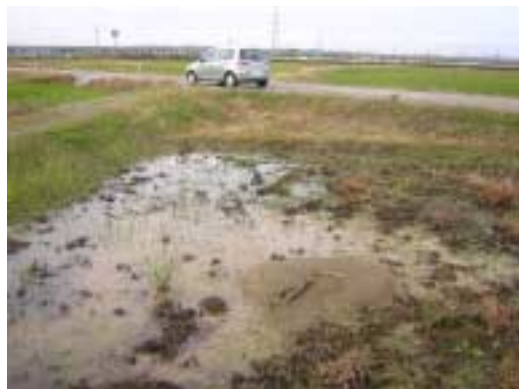
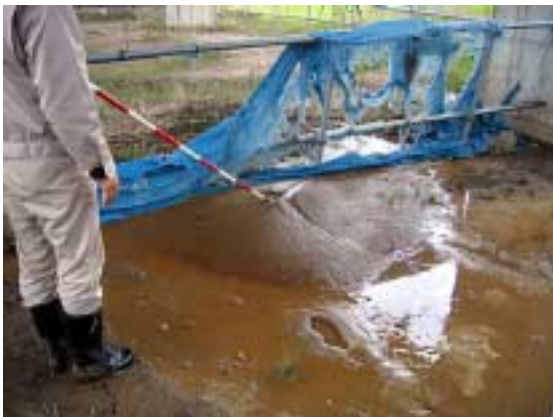
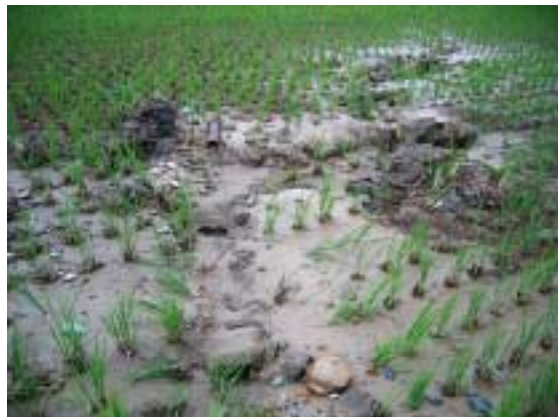
Soil Liquefaction was widespread all over the epicentral area. The soil liquefaction was observed from on both sides of Shinano River from Tokamachi to Nagaoka plain. Liquefaction was also observed at Joetsu city, Teradomari, Kashiwazaki along Japan Sea shores in north and Koide and Muikamachi in south. Since the soil layers are inclined towards Shinano-River, the lateral spreading and permanent displacement of ground induced by soil liquefaction took place. The soil liquefaction and associated lateral spreading caused extensive damage to linear structures such as railways, highways, embankments and viaducts of expressway and Shinkansen railways. The topsoil is mostly silty or clayey layer, which may act as a lid to prolong shaking and excess pore-pressure dissipation. Therefore, the sand volcanoes sometimes were missing although ground rupturing and ejection of mud were observed. Liquefied soil ranged from clayey soil to gravelly sand, including sand. Some sampling was done at several locations nearby Shinkansen line (Katada) where Shinkansen TOKI No: 325 derailed and Takiya. The physical and geotechnical properties of these soil samples are given in Table 8.1 and grain-size distributions are shown in Figure 8.1. Figure 8.2 shows the relation between the hypo-central distance and earthquake magnitude for liquefied sites together with liquefaction state limits developed for Turkish earthquakes (Aydan et al. 1999). Figure 8.3 shows several views of soil liquefaction in the earthquake-affected area. As it is noted from pictures, the ejection of gravels and clayey material was observed in the epicentral area and beneath Shinkansen line where the train was derailed. Furthermore, the splashing of muddy material on the columns of viaducts of Shinkansen line was 4m high in some places.

Figure 8.3: Examples of liquefaction (pictures by Aydan and Niigata University)

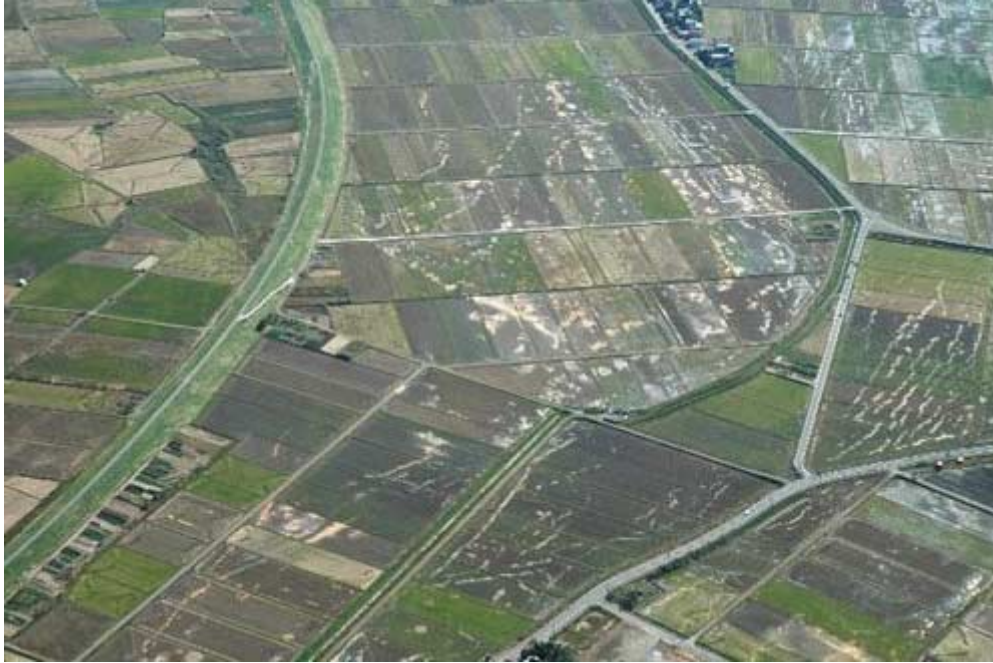
(a) Nagaoka

Figure 8.4 shows two aerial photographs taken nearby Ojiya and Nagaoka along Shinano River. In these pictures taken by several Aerial Surveying Companies, the sand volcanoes and ground ruptures associated with lateral spreading are clearly visible.

Figure 8.4: Aerial photographs of liquefaction and lateral spreading (from Aerial Surveying Companies)

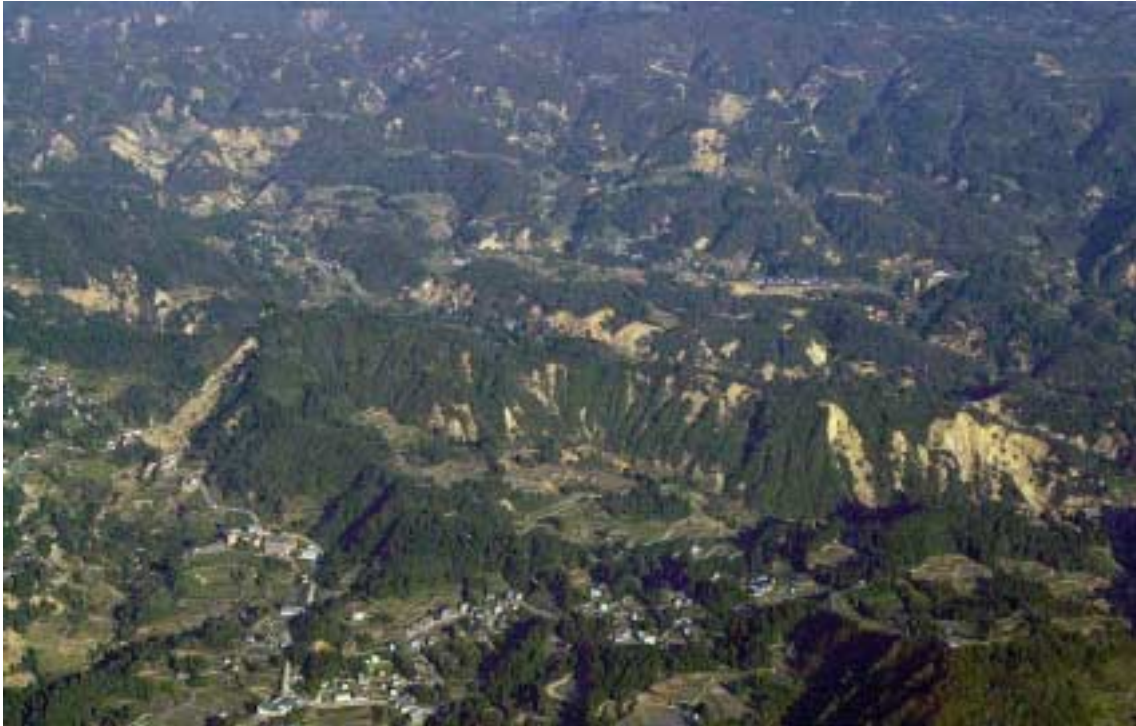
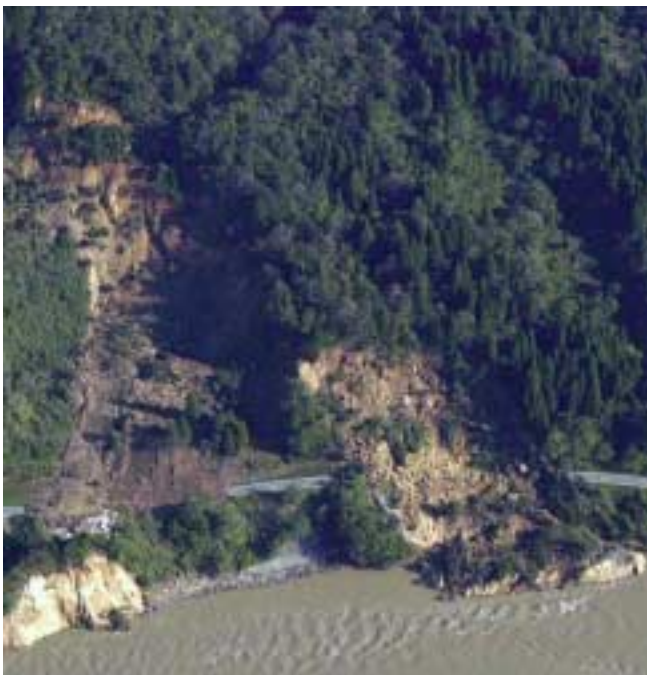
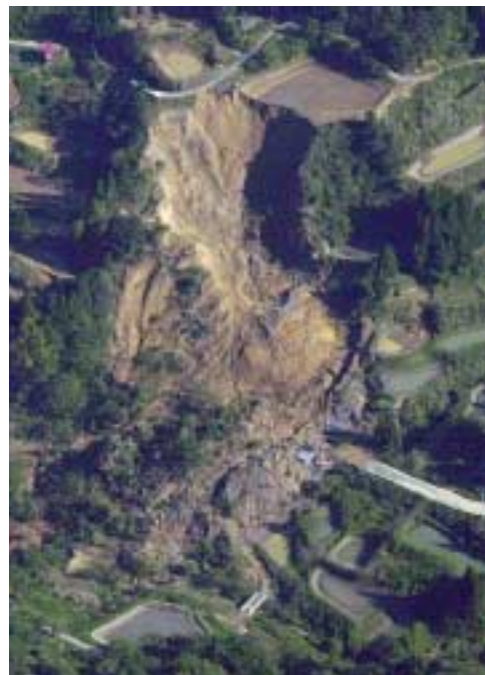
One of the most striking characteristics of this earthquake is extensive slope failure. The slope failures caused extensive damage on roadways, railways, and expressways as well as destroying homes. The most extensive slope failures were observed in Yamakoshi village. The area mainly consists of Neogenic mudstone. This mudstone near ground surface is highly weathered and it had become clayey soil. The slope failures in this area are associated with bedding planes which dip NE with an inclination ranging between 10-25 degrees. Before the earthquake, Typhoon No.23 passed over the earthquake epicentral area and resulted in very heavy rainfall. Therefore, rock mass and soil layers are expected to be fully saturated at the time of earthquake. The slope failures may be categorized as illustrated in Figure 8.5

Figure 8.6: Aerial photographs of slope failure at Yamakoshi and along Shinano River

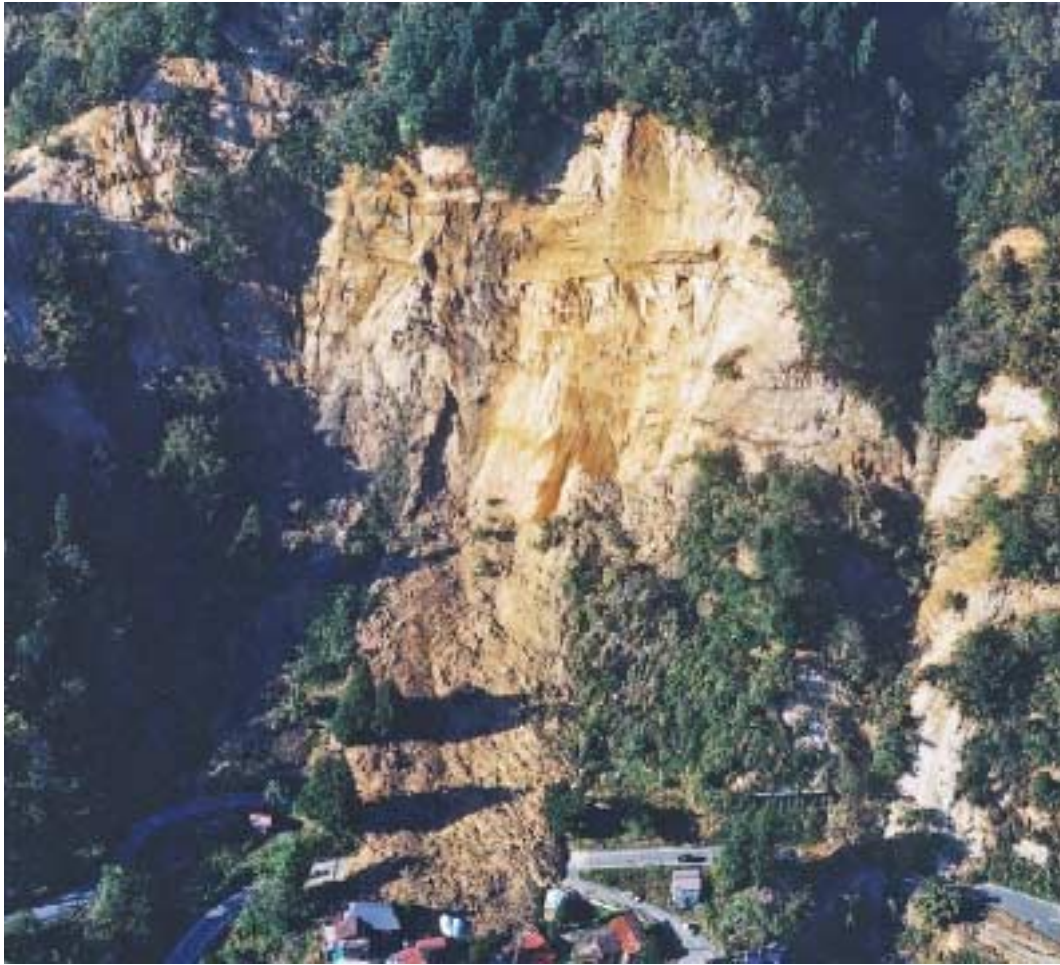
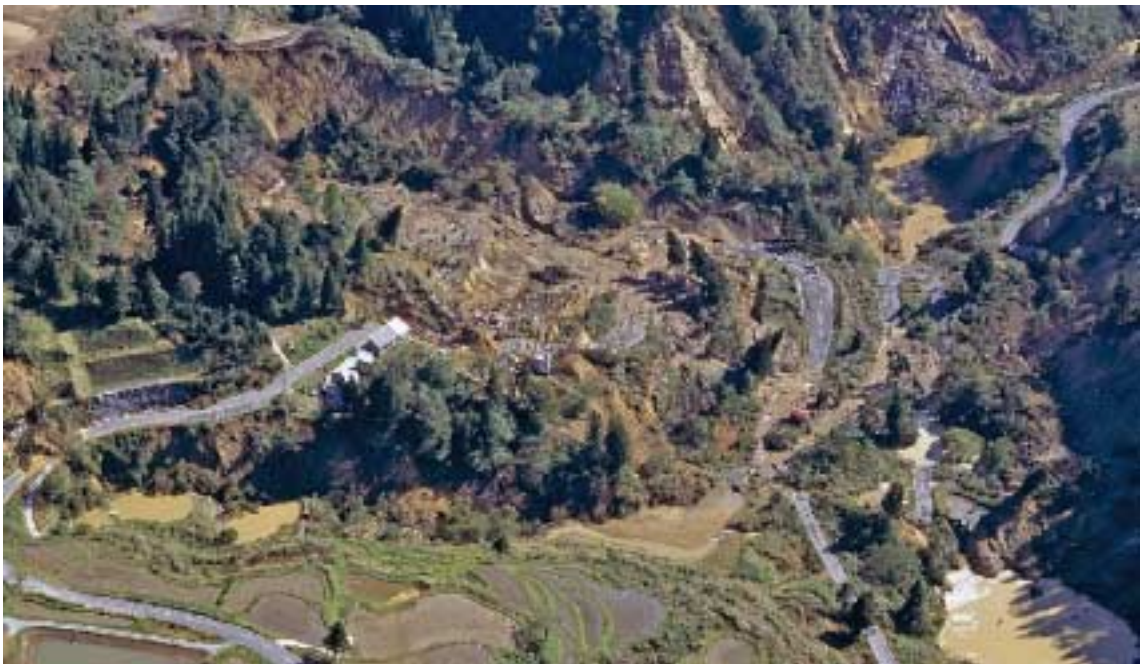
Figure 8.7 Slope failures

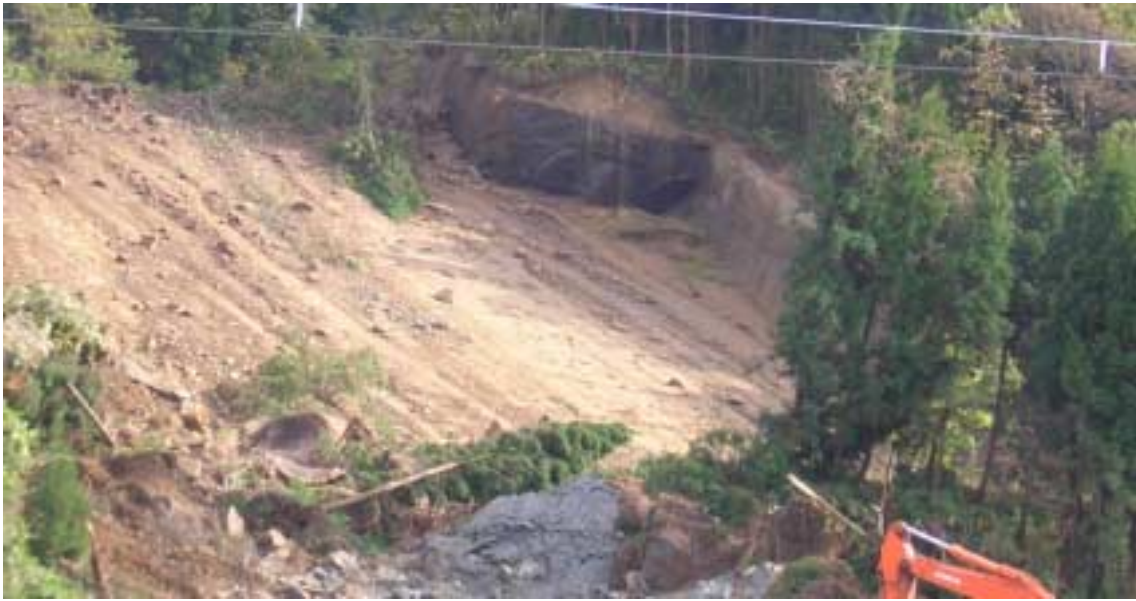
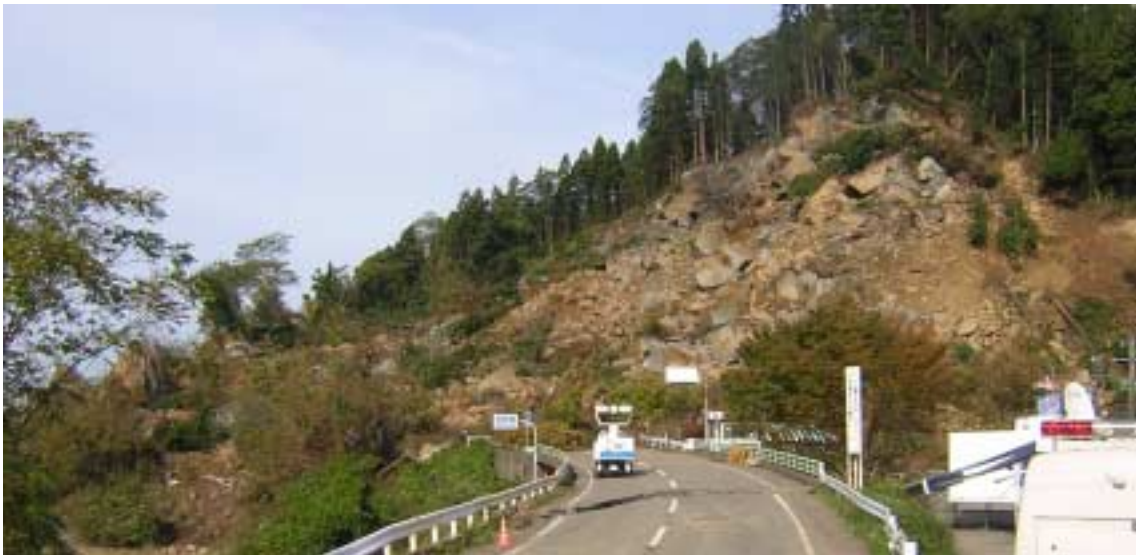
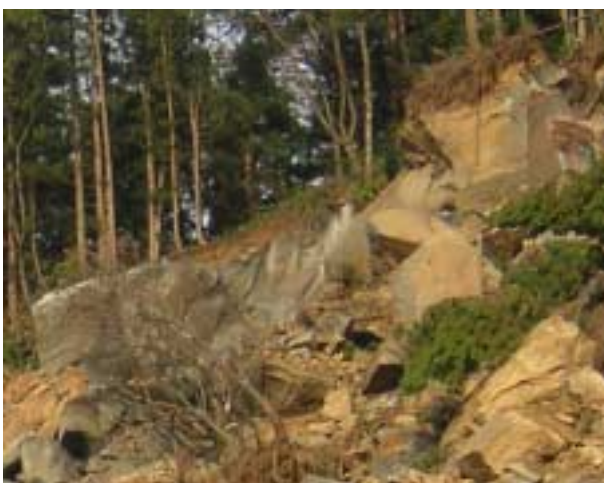
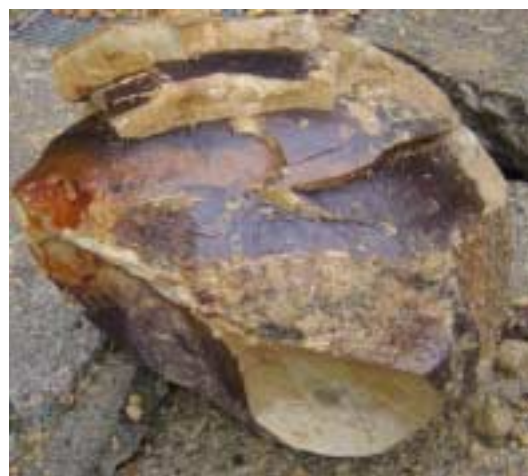
Figure 8.8: Planar Rock Slope failures

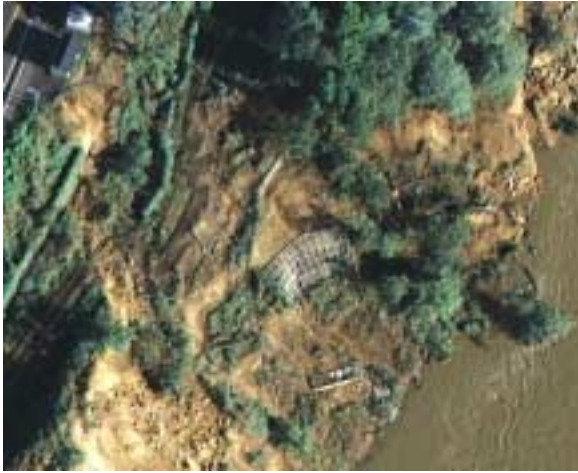
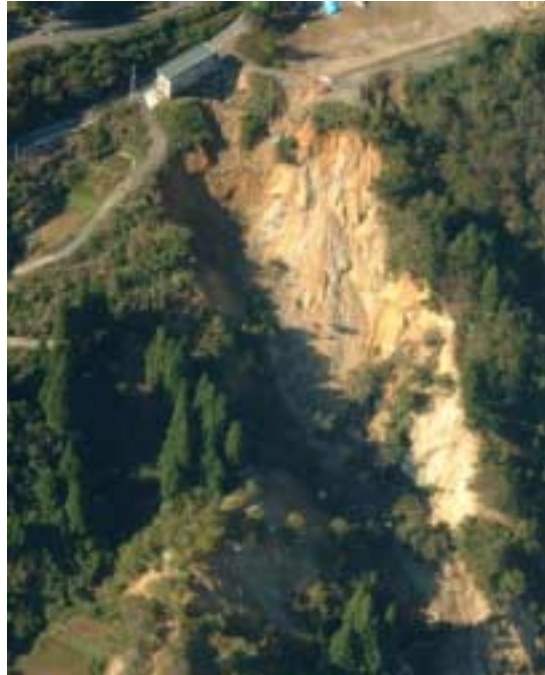
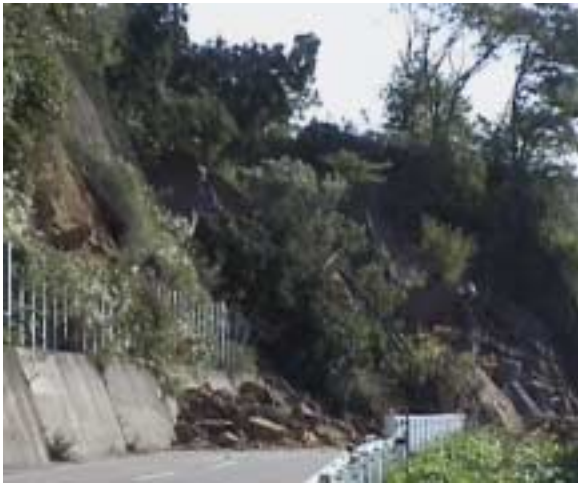
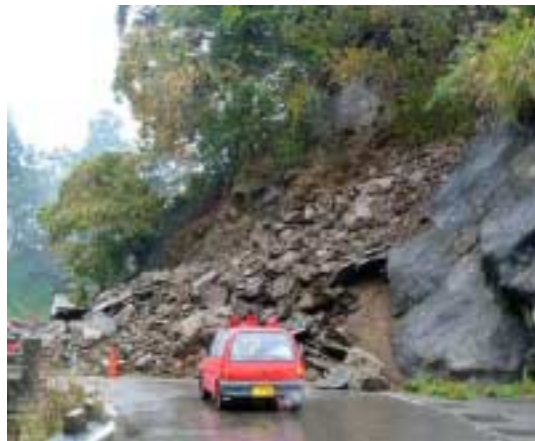
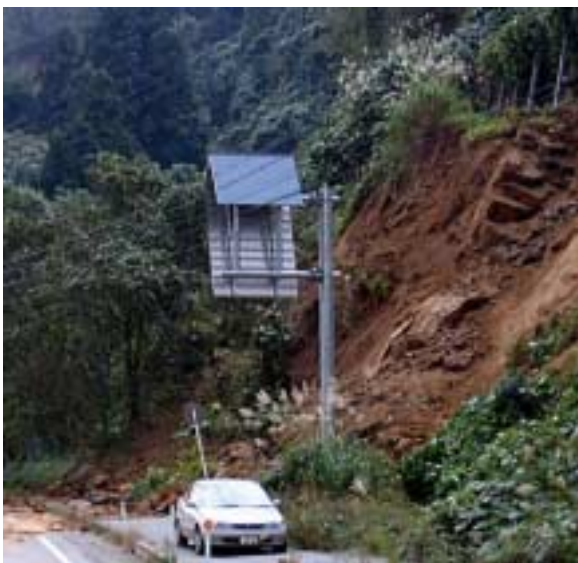
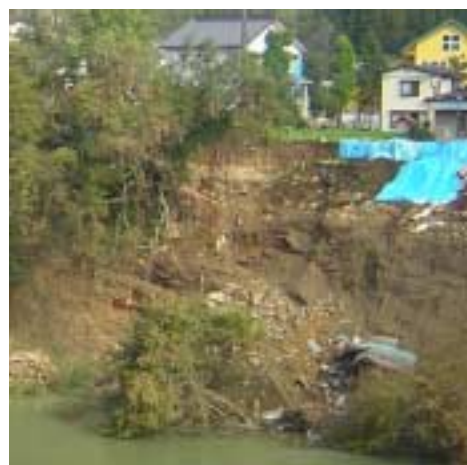
Figure 8.9: Wedge, toppling and combined rock slope failures

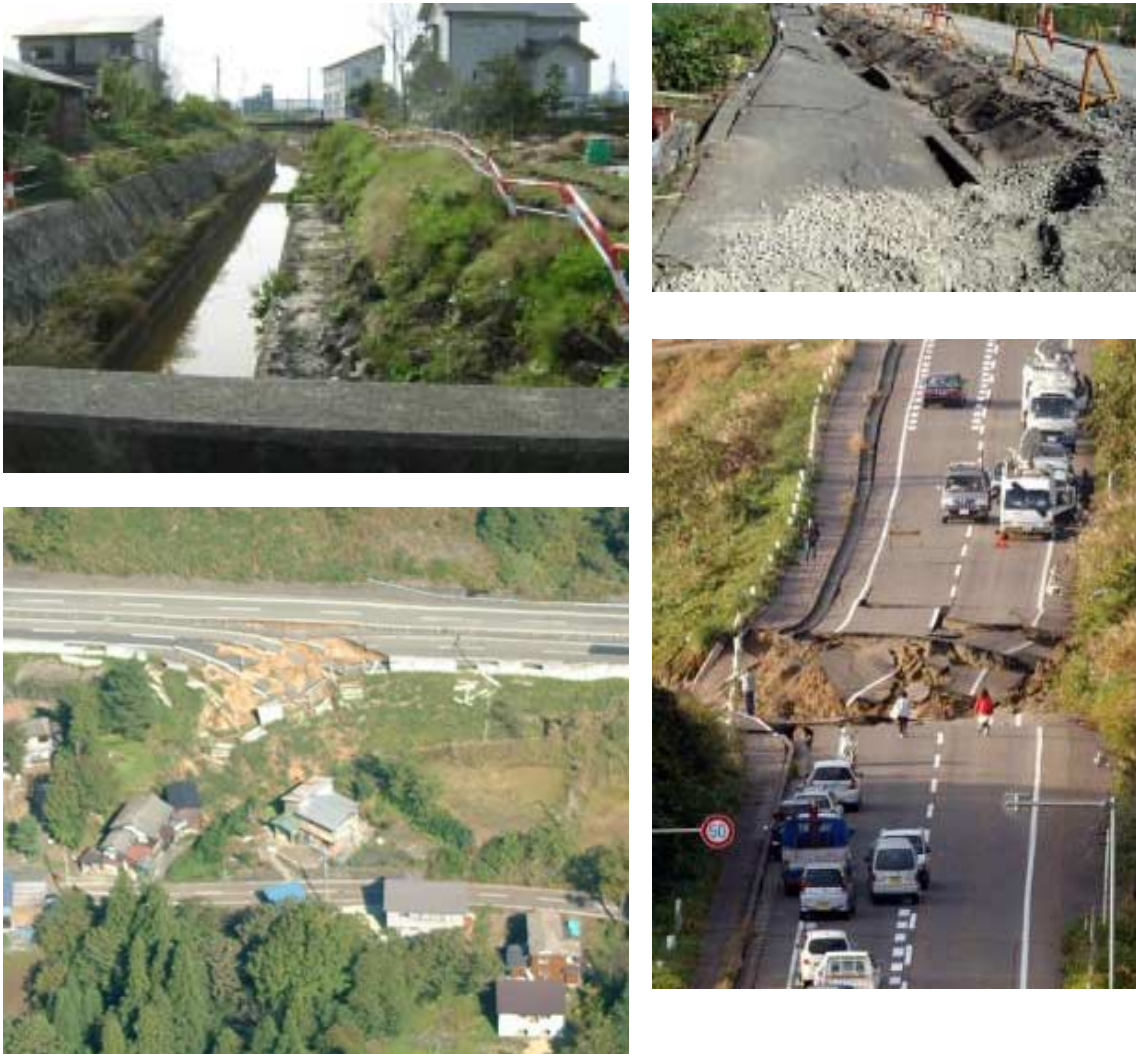
Embankment failures and settlements were widespread. Several typical examples are shown in Figure 8.10. The highways, Kanetsu expressway and railways are mainly built on the embankments. The embankments mostly failed in the form of curved sliding. Some failures were associated with the liquefaction of soil beneath the embankments.

Figure 8.10: Embankment failures

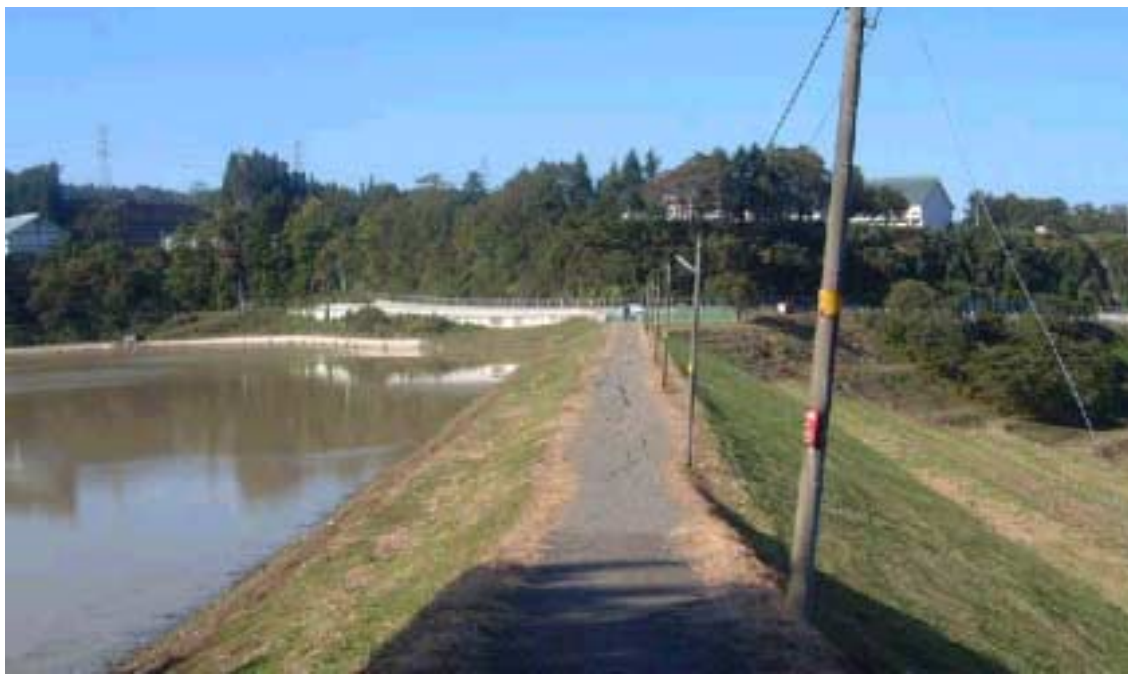
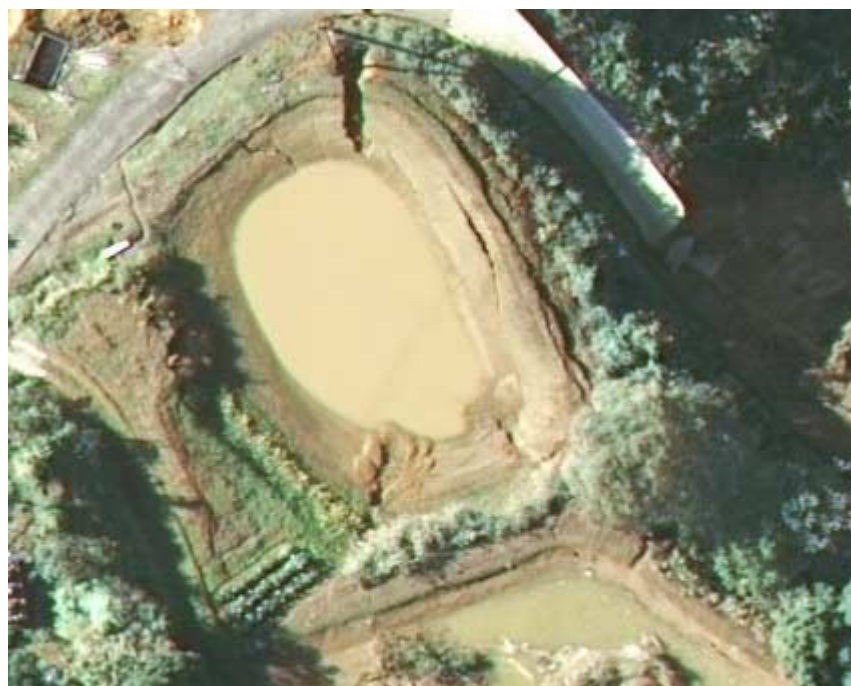
There are also some earth dams built for irrigation and drinking water purposes. The failure and settlement characteristics of embankments of these structures are basically the same. Some examples are shown in Figure 8.11.

Figure 8.11: Embankment failures associated with earth dams
