9 DAMAGE TO BUILDINGS

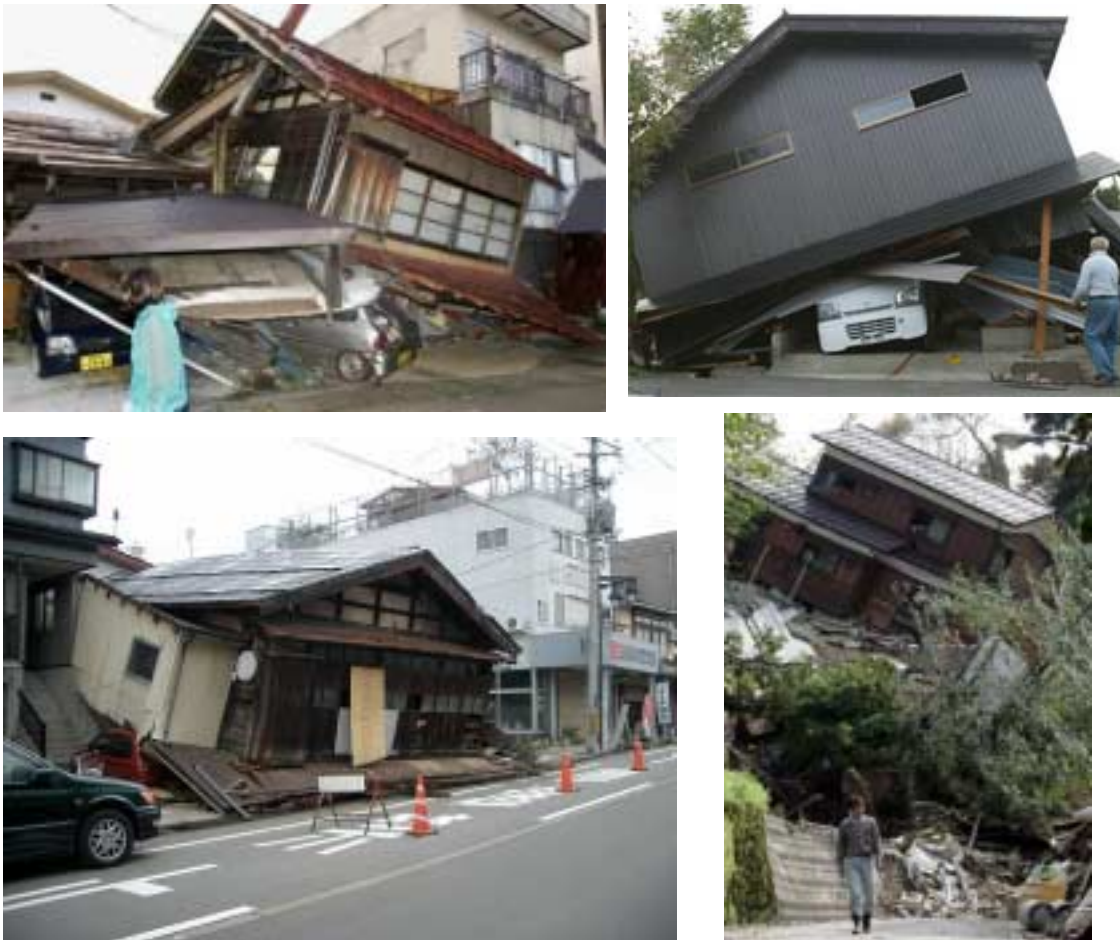
Mainly old wooden houses were either collapsed or heavily damaged. The failure was quite similar to those observed in 1995 Kobe earthquake. The failure mechanism mainly involved hinging of wooden columns at the base and also at the interface between 1st floor and 2nd floor as a result of large horizontal earthquake forces. The traces of such mechanism can be seen widespread in the epicentral area. In addition some relatively new wooden houses either collapsed or were heavily damaged. The main cause was the weak floor situation observed at the first floor used as garage, workshop or storage (Figure 9.1).

Figure 9.1: Collapse of wooden houses

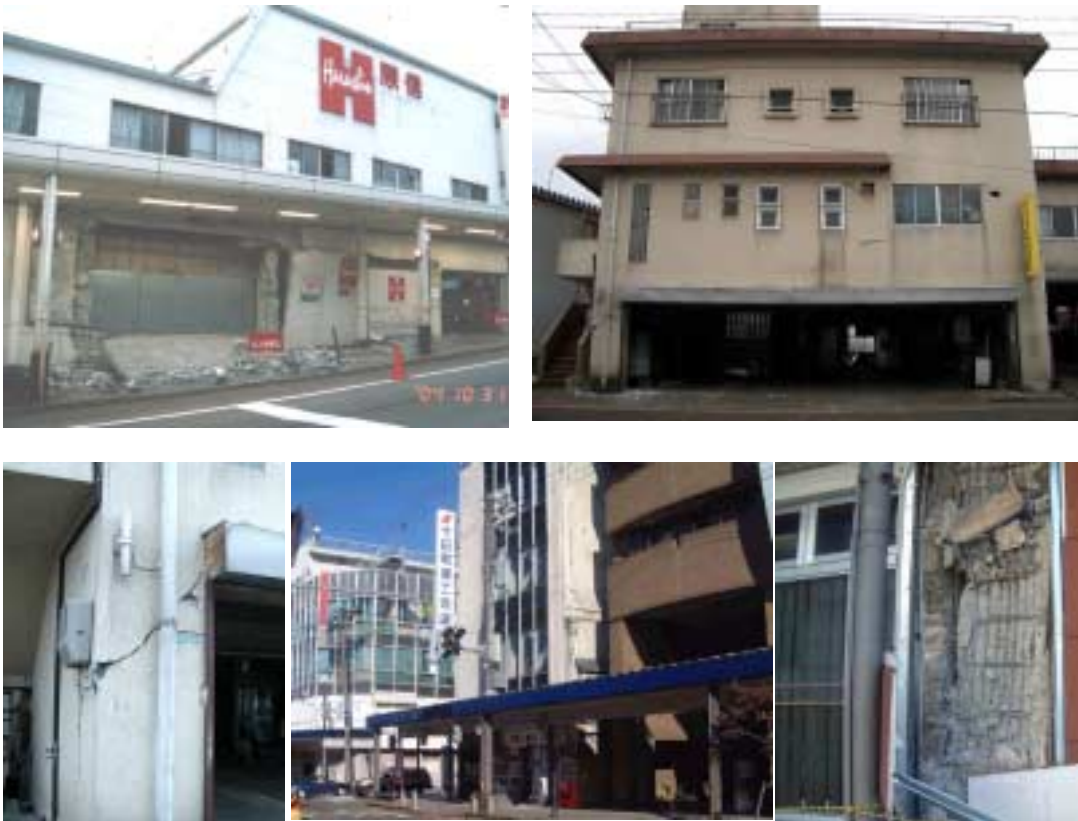
RC buildings with or without steel frames in the epicentral region are few. They are used as schools, public offices and a few residential buildings. The number of stories is mostly 3 to 5. Some residential buildings had 10 stories. Furthermore, the infill walls of the RC buildings were constructed with shear-walls. Therefore, their behavior should had been close to rigid boxes on softer ground. The observations and investigations in many cities and towns indicated that the RC buildings were generally none or slightly damaged in spite of high ground accelerations. Damage to RC buildings was caused by column failure at the ground floor. In some of buildings, the quality of concrete and density of stir-ups were not in accordance with regulations (Figure 9.2).

Figure 9.2: Damaged RC buildings
