4 TECTONICS

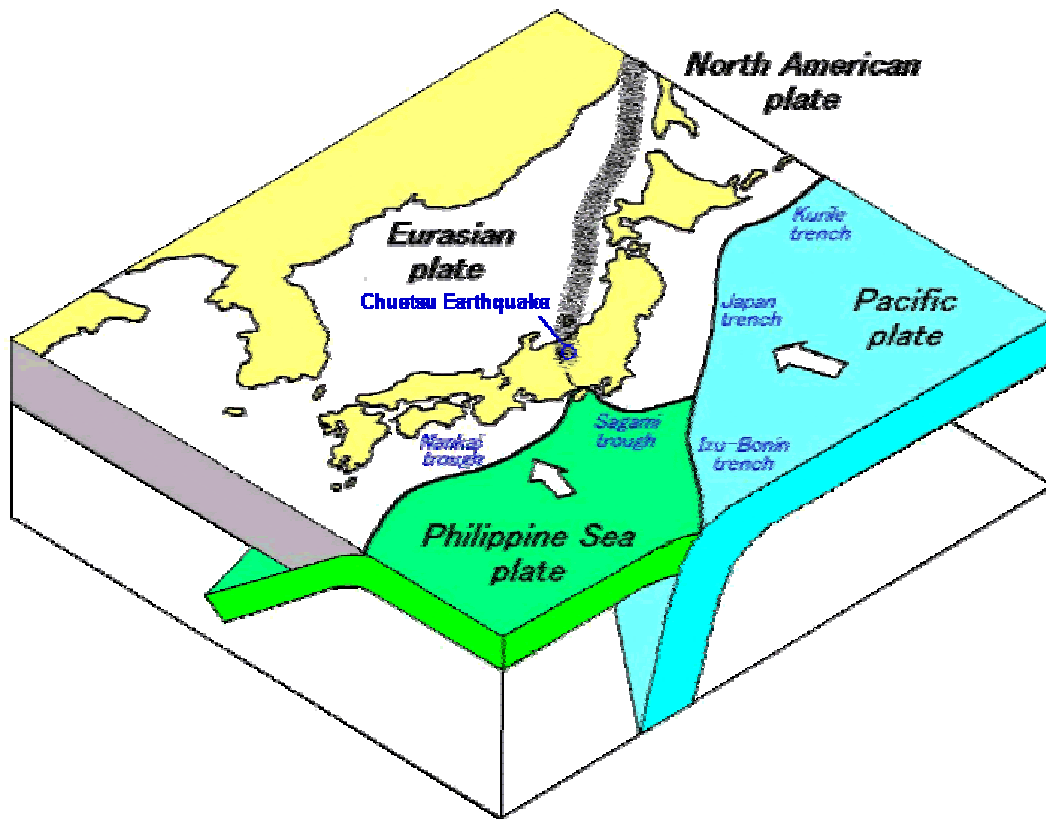
Figure 4.1: Plate tectonics interpretation of Japan and its close vicinity (modified from NIED)

The plate-tectonic interpretation of Japan and its close vicinity is illustrated in Figure 4.1. The earthquake seems to take place along a collision boundary between Euro-Asian Plate and North American Plate (?). The earthquake area is on the eastern part of Fossa-Magna and underwent extensive folding, which has been still proceeding. The folding axes are ruptured by seemingly sinistral lateral strike-slip faults along the valleys of Nagano-Joetsu, Yuzawa-Kashiwazaki, Yunozawa-Ojiya and Nagaoka-Teradomari. These valleys may be interpreted as kink bands.

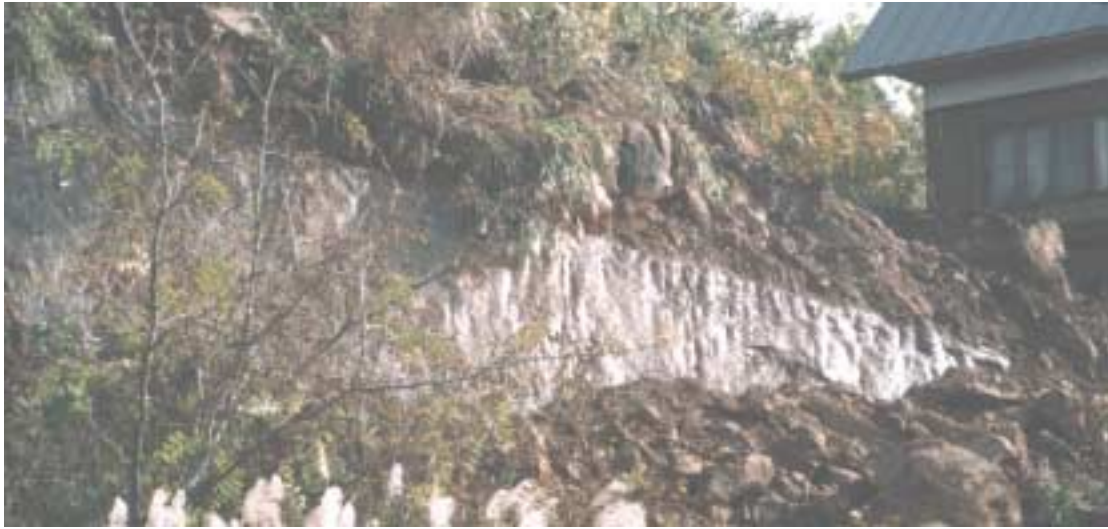
(a) Thrust fault nearby the landslide area in Ojiya

Figure 4.3: Faults observed during site investigations

The author noticed some faults during the investigation (Figure 4.3). One of these faults was observed on the eastern side of Shinano-river nearby the landslide area and the second one nearby Horinouchi town along the Kanetsu expressway. One of the surfaces is associated with a thrust fault and the other surface is a sinistral lateral strike-slip fault. Faulting mechanisms inferred from the faults in Horinouchi are shown in Figure 4.4.

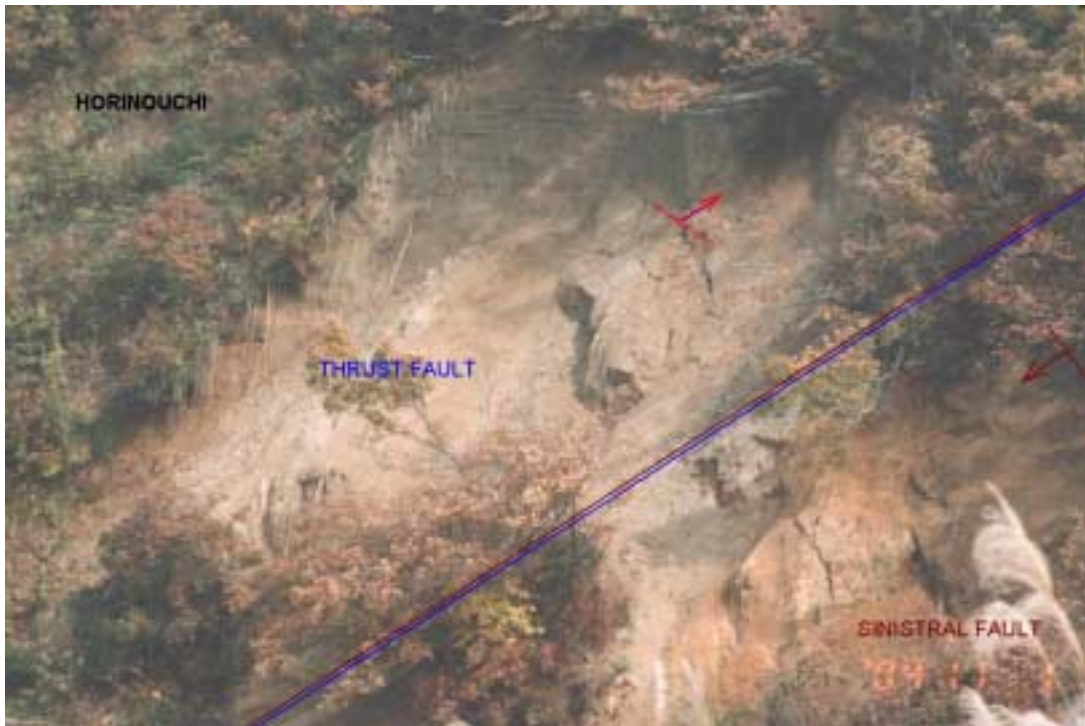
(b) Thrust and sinistral faults nearby Horinouchi along Kanetsu expressway

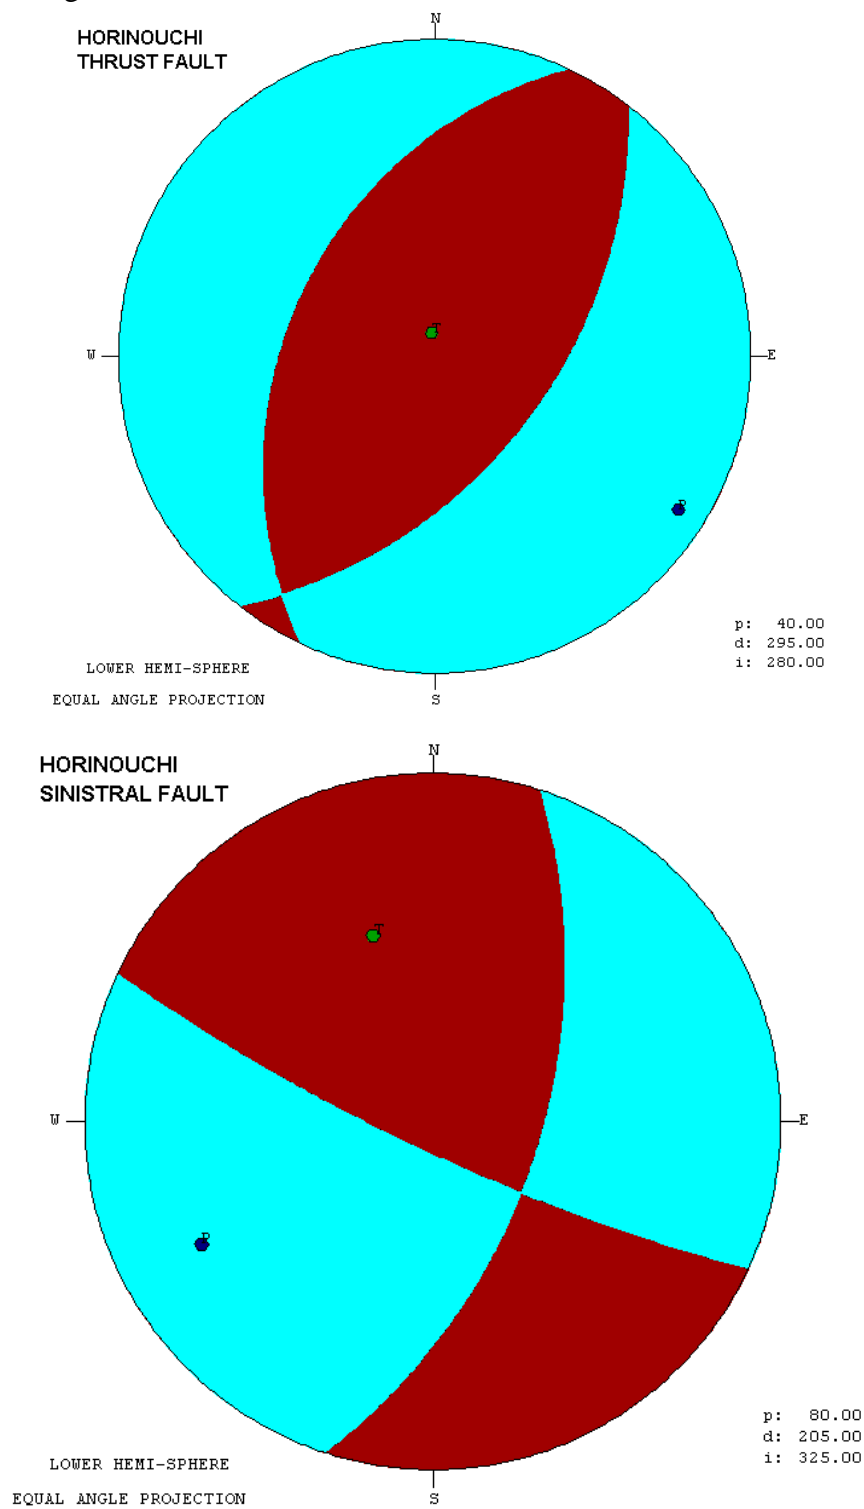
Figure 4.4: Inferred faulting mechanisms for faults nearby Horinouchi

earthquakes occurred before October 23, 2004 has similar faulting mechanism to the main event. Furthermore, faulting mechanisms shown in Figure 4.4 are quite similar to those shown in Figure 4.6.
