## 8 GEOTECHNICAL DAMAGE

### 8.1 Soil Liquefaction and Lateral spreading

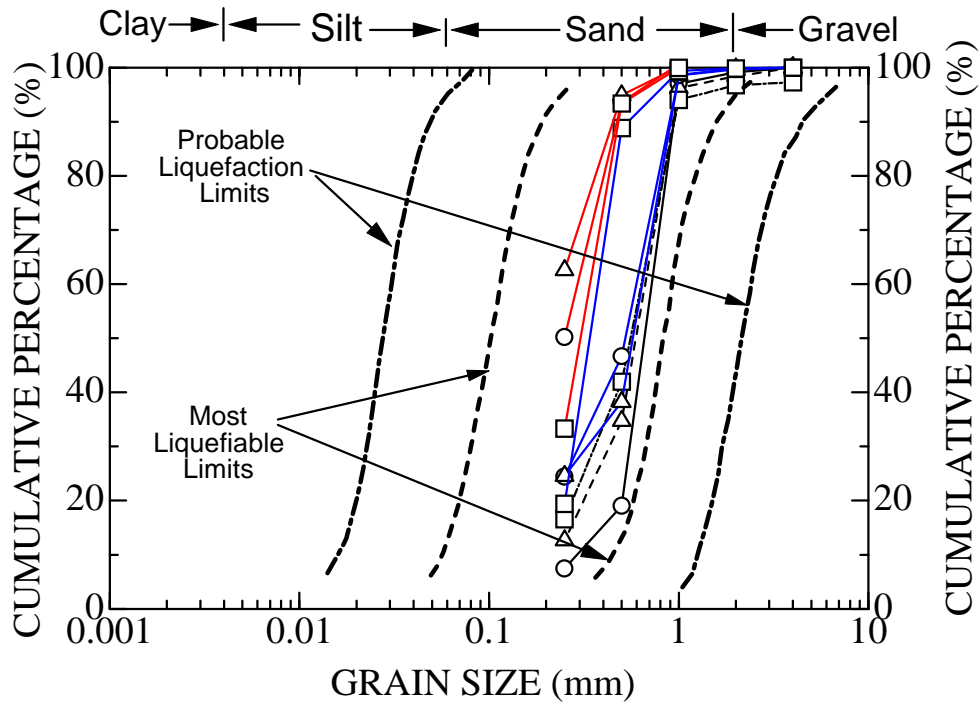
Table 8.1: Properties of liquefied soil samples collected from sand volcanoes

Soil Sample Location	Dry Unit Weight (kN/m <sup>3</sup> )	Porosity (%)	Mean Grain Size D <sub>50</sub> (mm)	Friction Angle (°)
Katada-manhole	11.0-12.5	37.3	0.610	30-32
Katada-Shinkansen	13.2-13.3	42.7	0.533	29-31
Takiya-field	13.2-13.8	40.0	0.247	27-31

Figure 8.1: Grain size distribution of samples collected from sand volcanoes

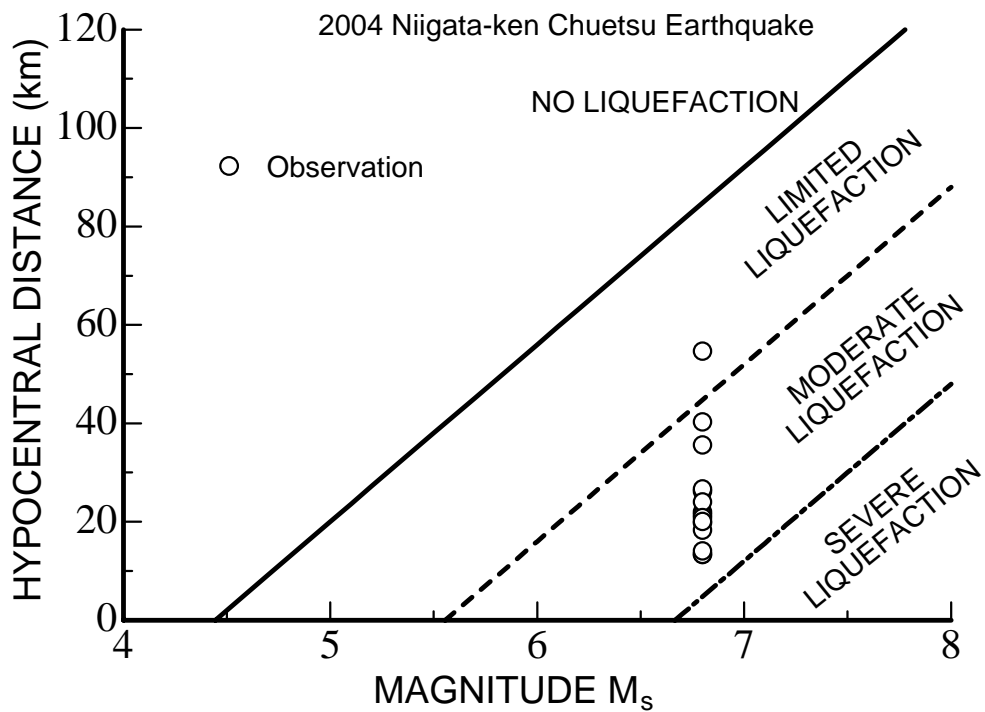
Figure 8.2: The relation between the hypo-central distance and earthquake magnitude together with liquefaction state limits for Turkish earthquakes

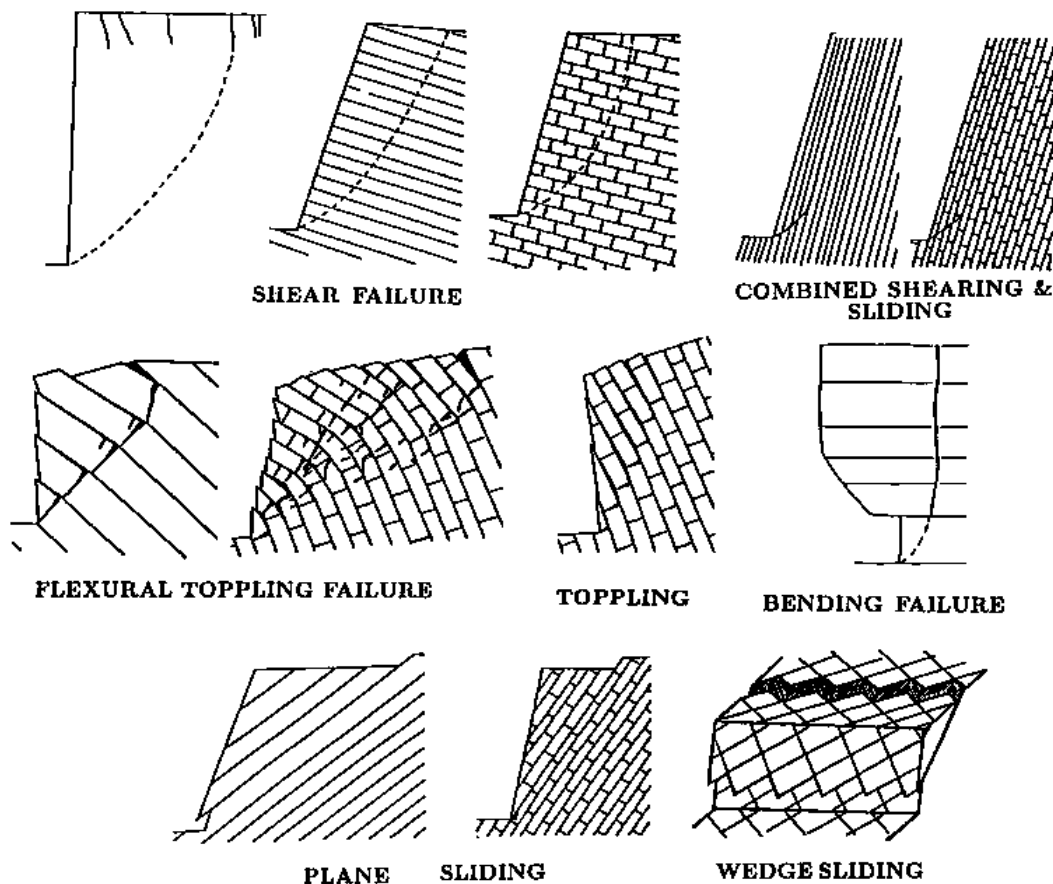
- a) Curved deep-seated slope failures (shear or sliding – Figure 8.6)
- b) Shallow seated slope failures (flexural toppling, combined sliding and shearing – Figure 8.7)
- c) Sliding failure (plane sliding, wedge sliding – Figure 8.8)
- d) Rock-falls (toppling, bending failure – Figure 8.9)

Figure 8.5: Classification of slope failures (arranged from Aydan 1989)
